Southern Region Engineering Office, Railway Reconstruction Bureau, MOTC

# Safety Challenge for Railway Underground Reconstruction at Metro Area of Kaoshiung in Taiwan

CECI Engineering Consultants, Inc., Taiwan

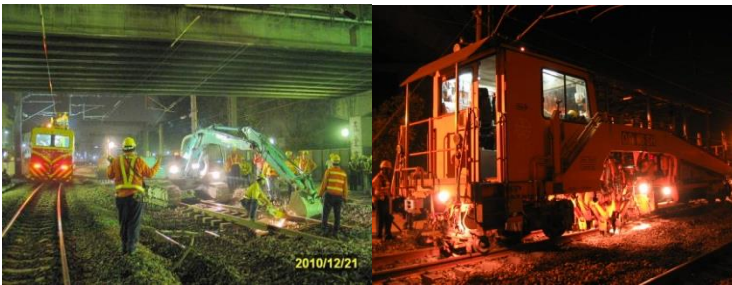
✓ Distance <1.5m

Track & signal shift during 6 Hrs

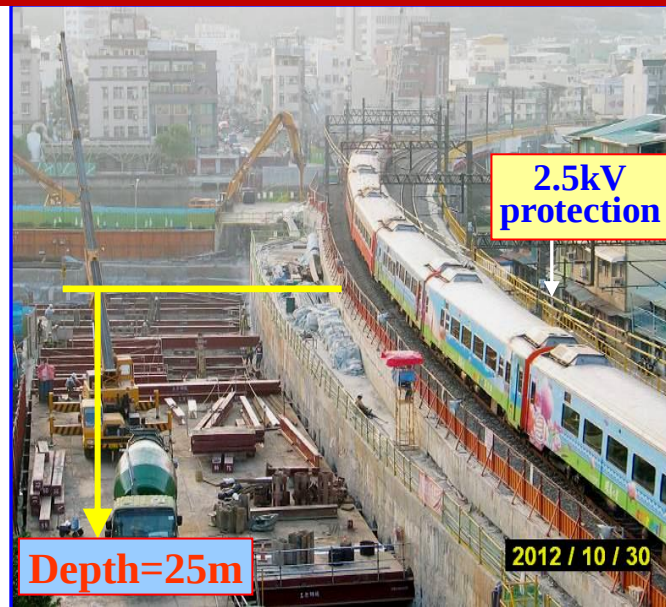
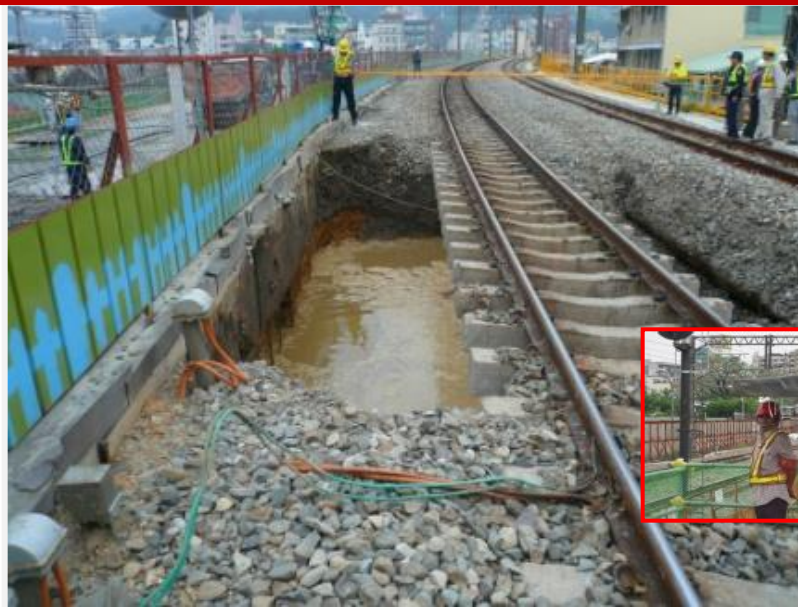
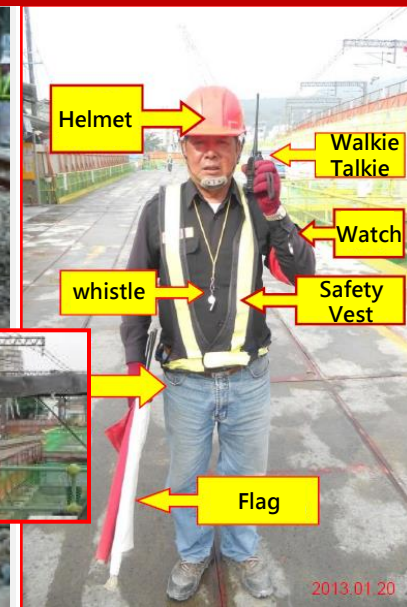
Deep Excavation  
& Complicated Lifelines  
& High Water Table  
& Soft/loose Ground

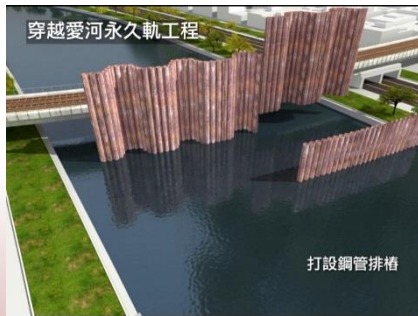
(1) Sheet/Pipe pile

## Non-flood season(Nov.~April)

- Non-flood : 6 months to construct cofferdam & river bed slab, and removing sheet pile before flood season(May~Oct.)

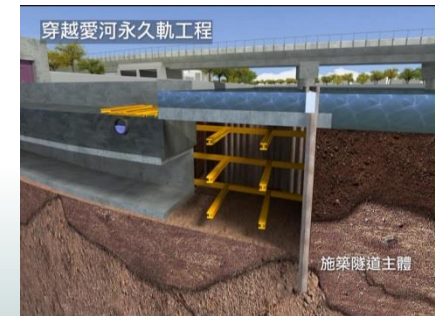
(4) Tunnel Structure

## Flood season

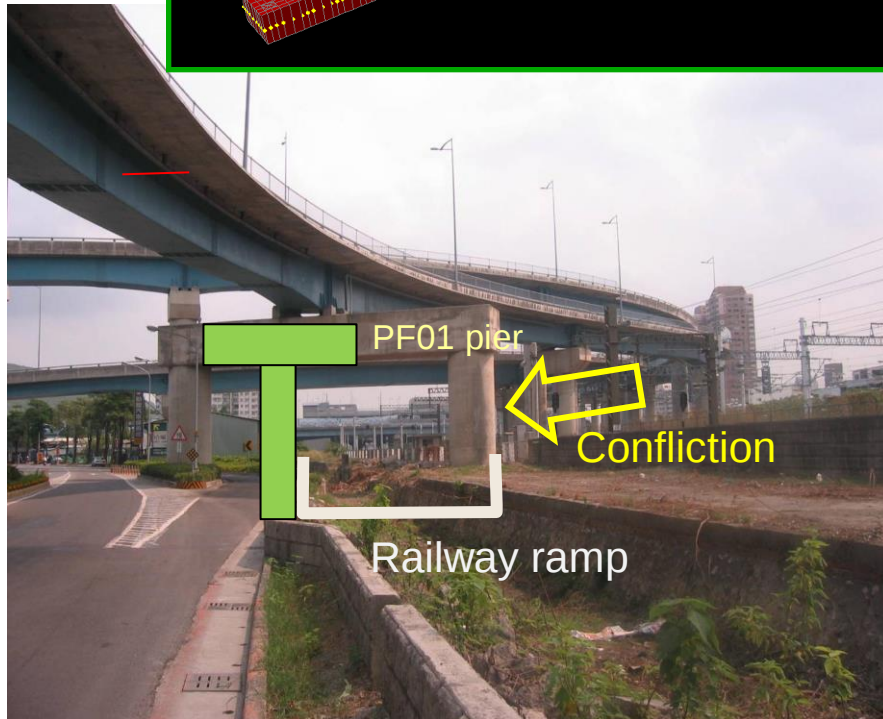
Da-Chung Bridge

- Confliction between PF01 bridge pier and approach section of tunnel
- Using existing foundation and build new underpinning pier

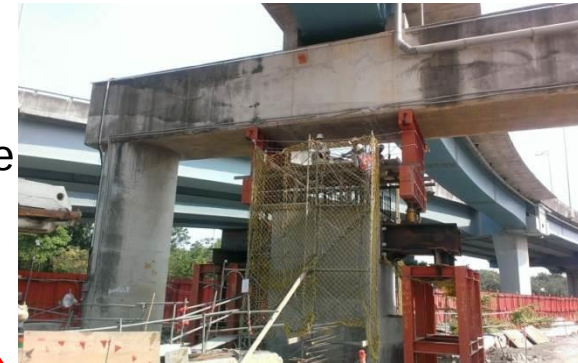
Hilti-anchorage  
( 42 bolts)

Hinge  
(Rebar coupler)

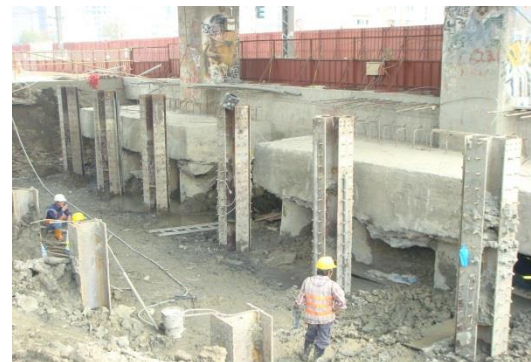
7. Cut off & remove support pile & column
8. Sta. decoration
9. Tear down the Chin-Hei bridge

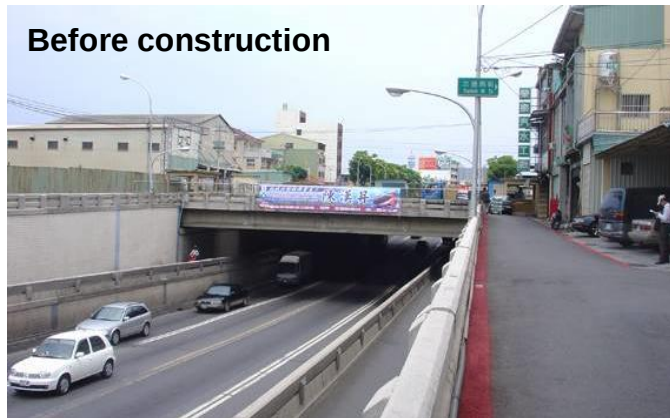
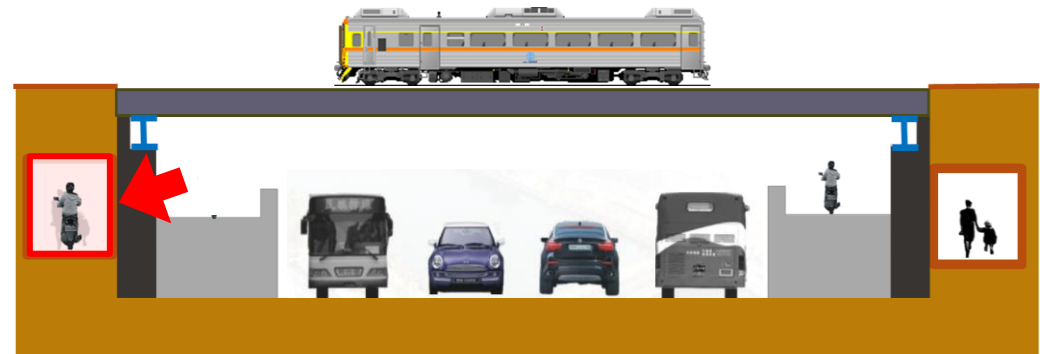
Chung Wha-3 road

- Maintain the traffic lanes → Rebuild the sidewalk tunnel into motor tunnel
- Cavity → Grouting around the interface of slab & Semi top-down construction method to shorten the time and quickly recover the traffic

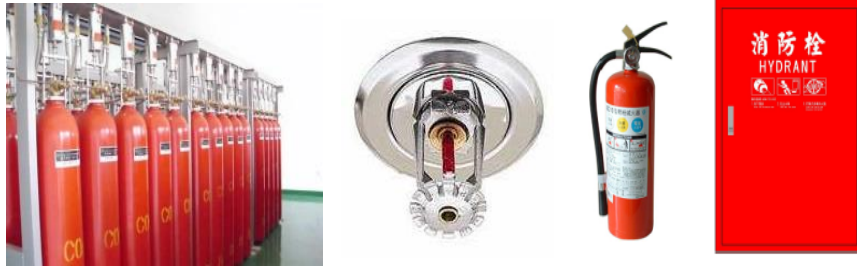
### Early Fire Fighting

#### Extinguishing
